Intel[®] Xeon[®] Processor E7-8800/ 4800/2800 Product Families

Specification Update

August 2015

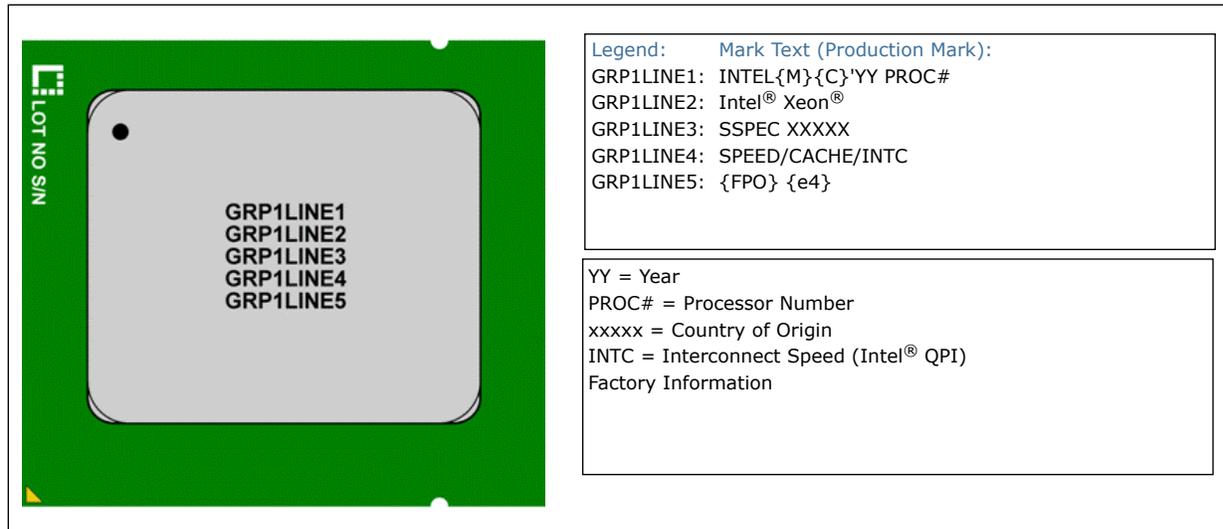
Figure 1. Processor Top-Side Marking (Example)

Intel® Xeon® Processor E7-8800/4800/2800 Product Families can be identified by the following component markings:
